CASE STUDY

A 19th century historic property

Holyrood Park Lodge

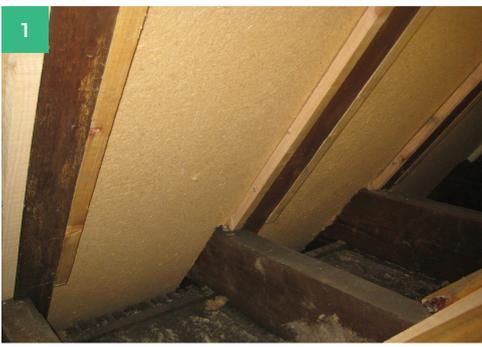
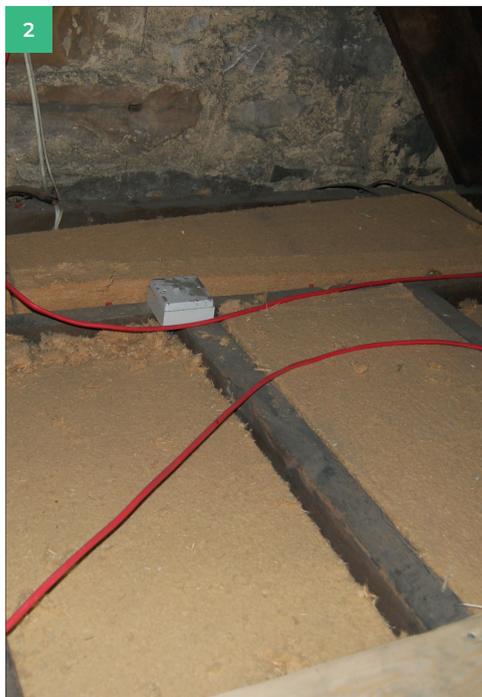
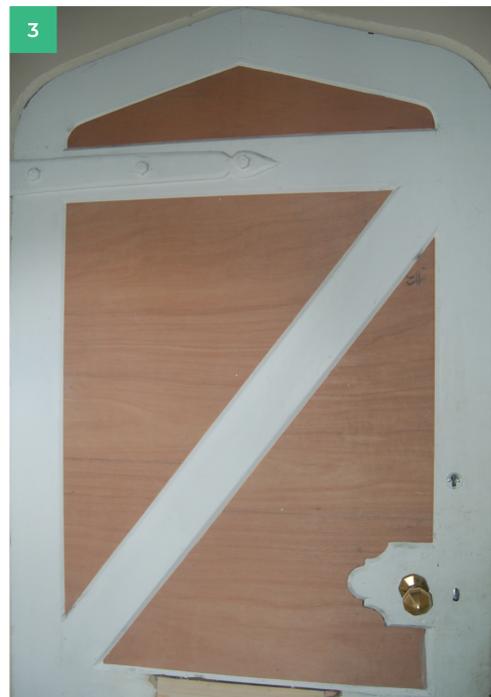
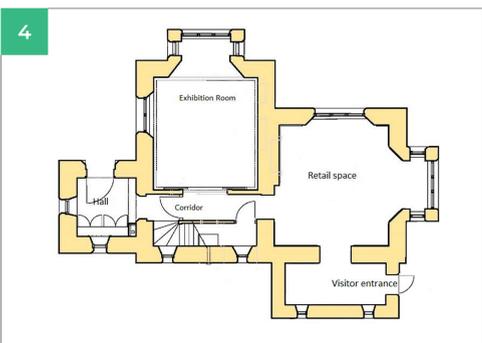
- Wood-fibre insulation in the south gable space; a 'warm roof'. Note the insulation continuing down in the coomb.
- Wood-fibre insulation batts laid flat between the ceiling joists to give a 'cold roof'.
- Ledged and braced door at the Lodge, before redecoration, showing the plywood panel on top of the aerogel board.
- Ground floor plan of the Lodge as proposed.
- Thermal imaging of 'leaky' doors and windows before and after.
- Energy performance certificate Band C.
